## AVIATION INVESTIGATION REPORT

A03O0088

### STALL/SPIN AND COLLISION WITH TERRAIN

FOUND AIRCRAFT CANADA INC. FBA-2C1 BUSH HAWK,

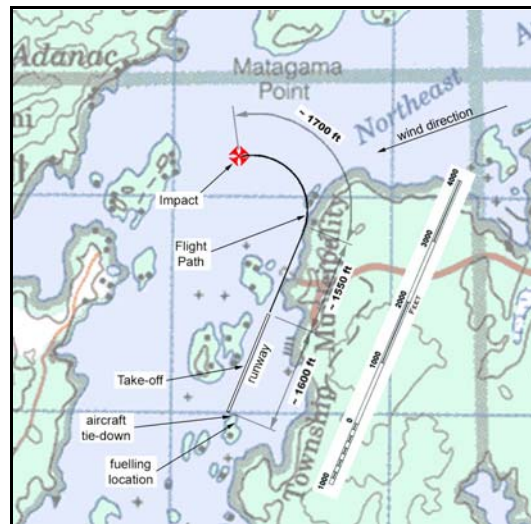
Figure 1. Accident Site

The flight path of the aircraft is presented at figure one. The runway and initial climb path were sheltered by trees on the right. As the aircraft emerged above the height of the trees during the climb, it was increasingly exposed to the wind from the northeast. When the aircraft turned to the left, the wind changed from a quartering head-wind to a tail-wind. The Transport Canada Flight Instructor Guide<sup>4</sup> describes a number of illusions that can be created by drift of an aircraft in low-level flight. Specifically, a turn from headwind to downwind produces an illusion of a slip inwards followed by an illusion of increased airspeed.
